May 30, 2012

SUBJECT: Wetland & Floodplain Evaluation Letter
Ashley House Apartments
109 East Hill Street
Valdosta, Lowndes County, Georgia
GEC Job #120184.241

Figure 1
U.S.G.S. Topographic Map
Ashley House Apartments
Valdosta, Lowndes County, Georgia
GEC Project No. 120184.241
Approximate Scale: 1" = 2,000'
Source: Valdosta, GA Quadrangle (1997)

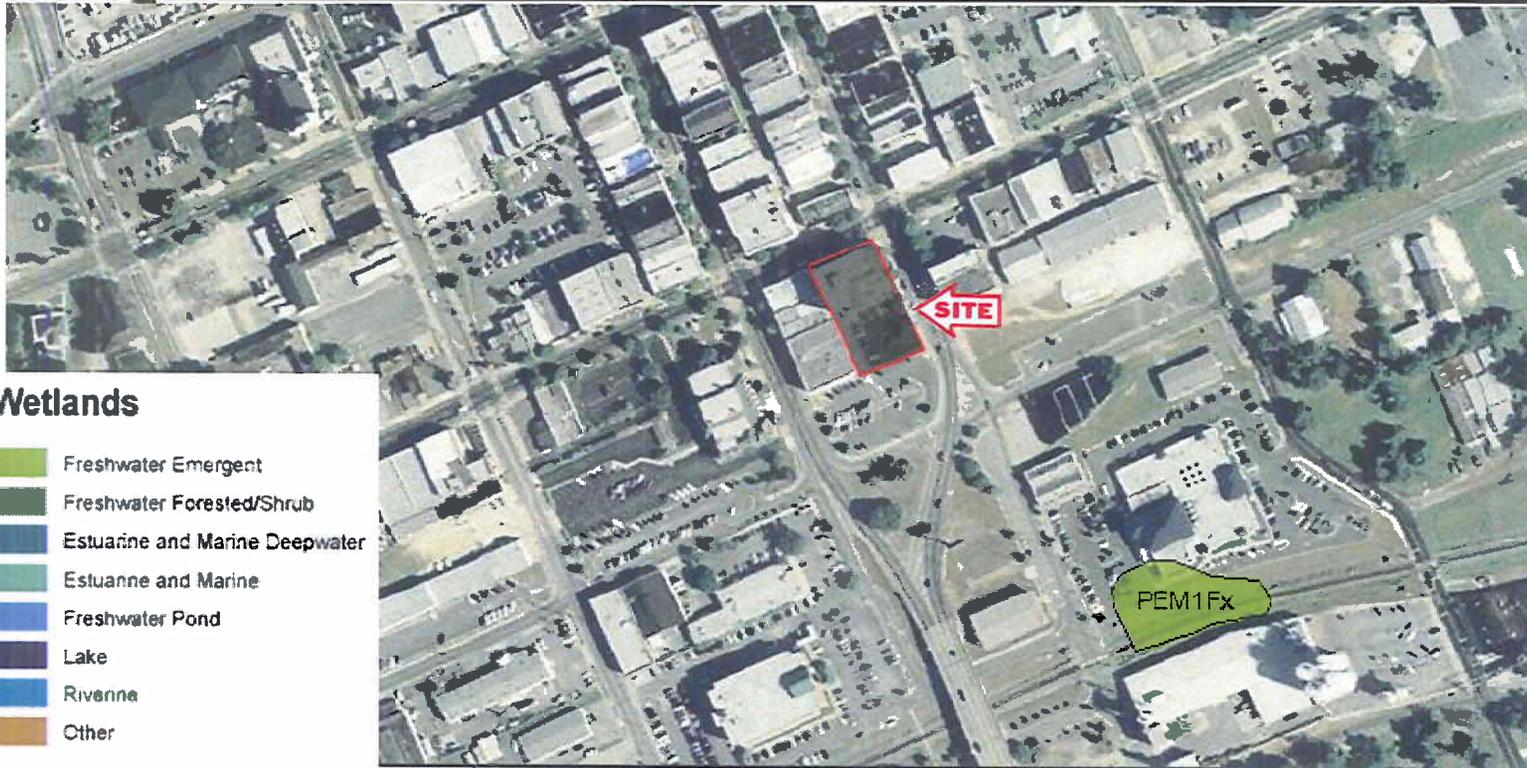
Per your request, Geotechnical & Environmental Consultants, Inc. (GEC) has reviewed the National Wetlands Inventory (NWI) map and the Federal Emergency Management Agency (FEMA) Flood Insurance Rate Map (FIRM) to determine if these records indicate potential wetland and/or floodplain concerns on the above property. According to the NWI map, no wetland areas were identified on the property, and our evaluation of the cited records did not identify any obvious areas of wetlands on the subject property.

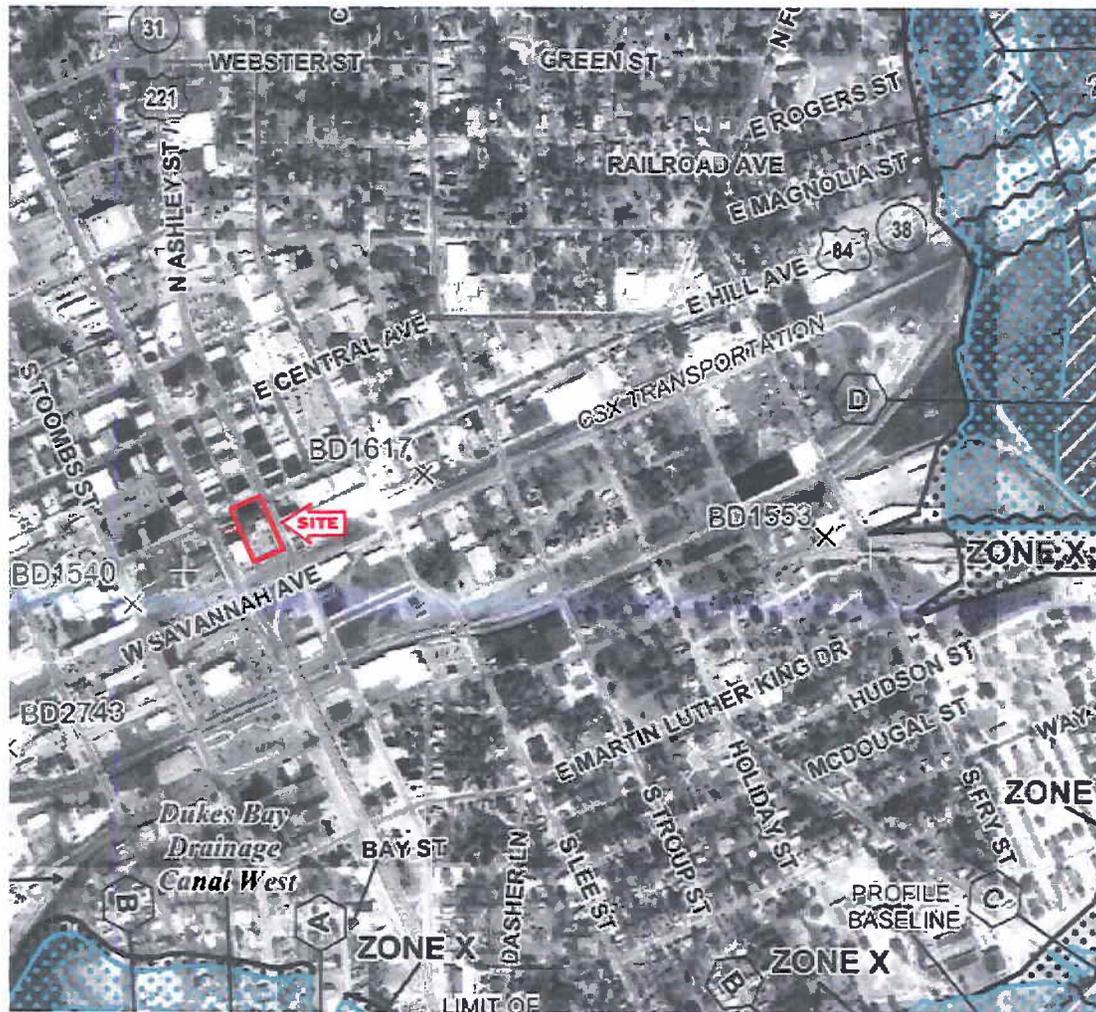
NFP

The subject property is found on the Lowndes County, Georgia Flood Insurance Rate Map (13185C0210E) dated September 26, 2008. According to the FIRM map, the subject property is located in Zone X-white, which is defined as areas determined to be outside the 0.2% annual chance floodplain. GEC, therefore, does not anticipate that a flooding hazard will deter the development of the subject property.

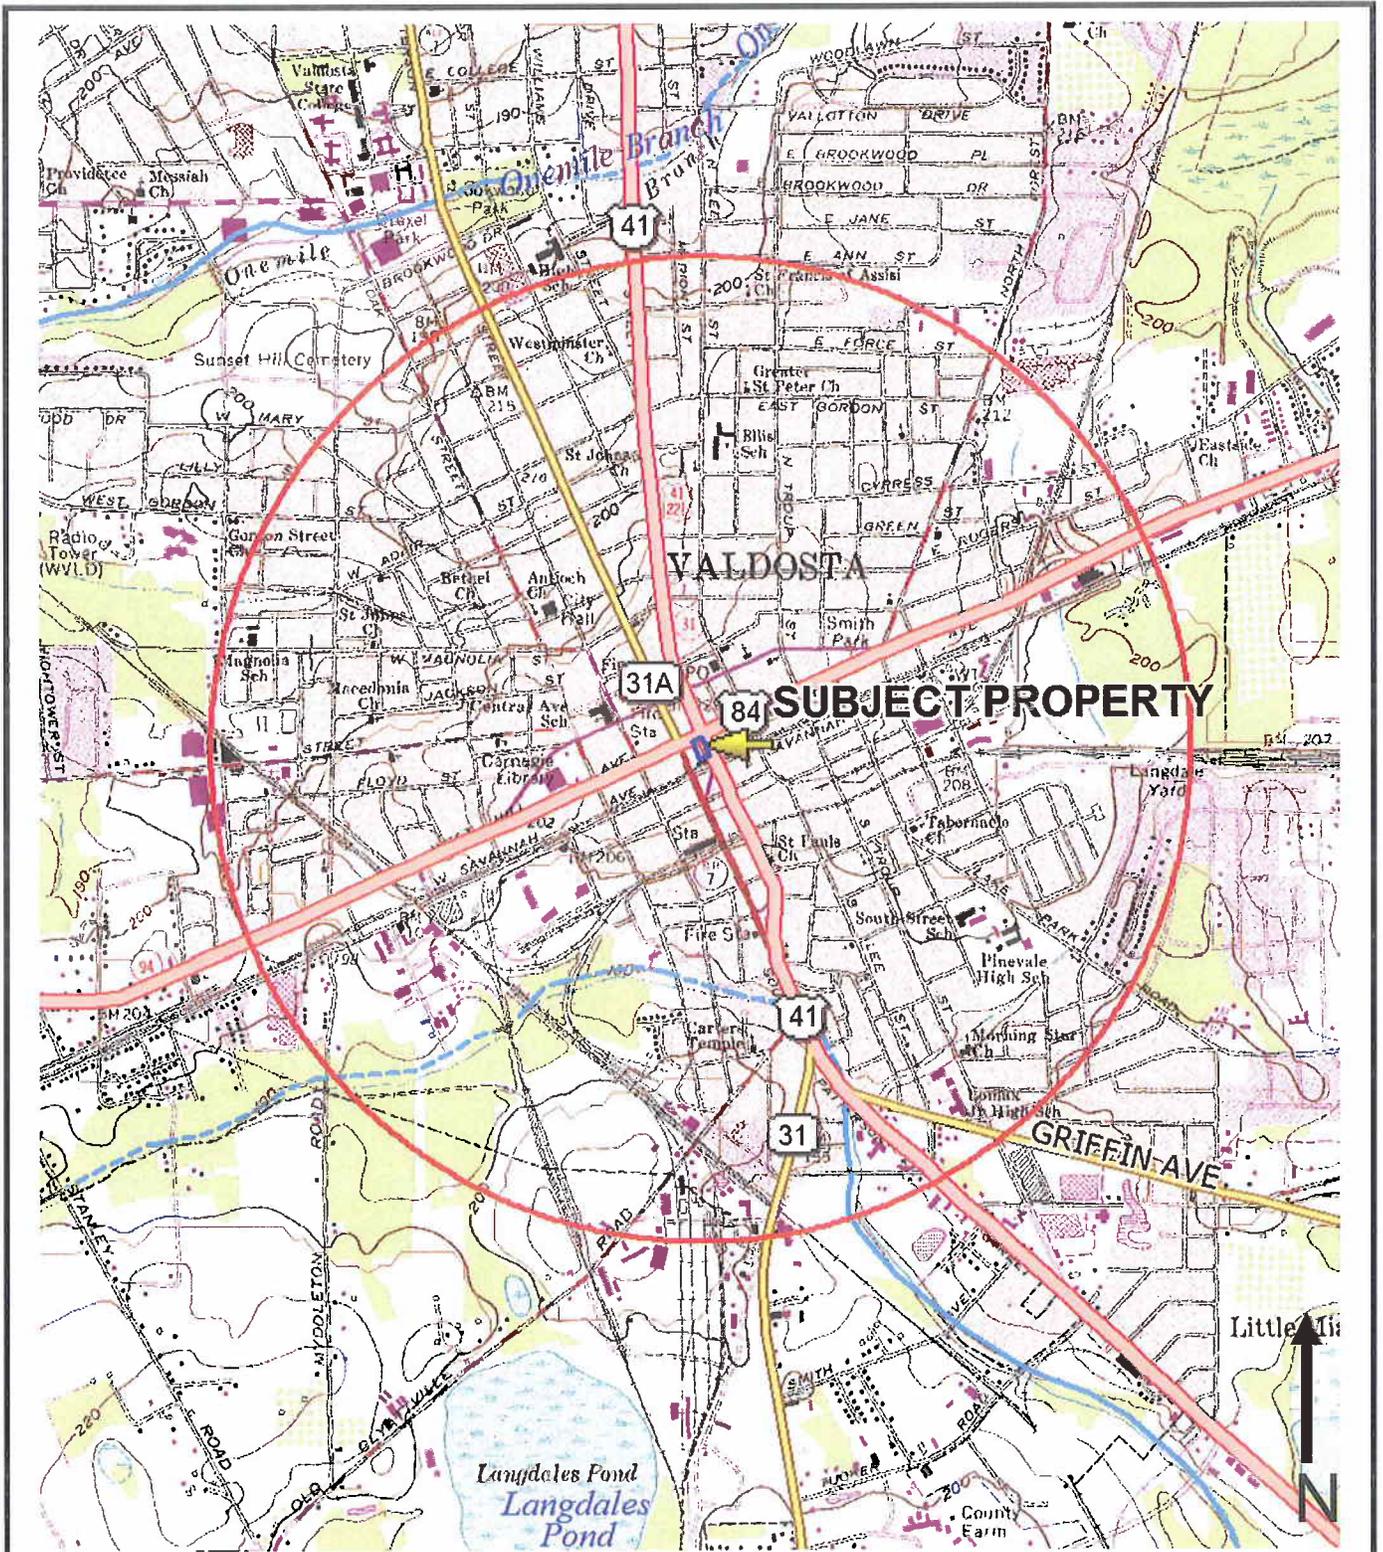
The Ashley House Apartments site, approximately 0.46 acres in size, is located at 109 East Hill Avenue. The subject property is situated south of W. Hill Avenue, east of Ashley Street, north of E. Savannah Avenue, and west of S. Patterson Street in the City of Valdosta, Georgia. The subject property is rectangular in shape, and its longer axis is actually oriented in a north-northeasterly direction, but for the purposes of this report, Hill Avenue is assumed to run east-west, and north parallels Ashley Street as shown in Figure 6. GEC observed that the subject site is currently a developed mid-rise apartment building. The site vicinity currently consists of commercial properties and parking areas. GEC observed retail businesses bordering the subject site to the north. Retail businesses and vacant/city parking was observed bordering the subject site to the east. Parking was observed bordering the subject site to the south and other retail businesses were observed bordering the subject site to the west. A site map and a site plan are included in Appendix A as Figures 5 and 6, and a U.S.G.S. topographic map depicting the site location is presented in Appendix A as Figure 1.

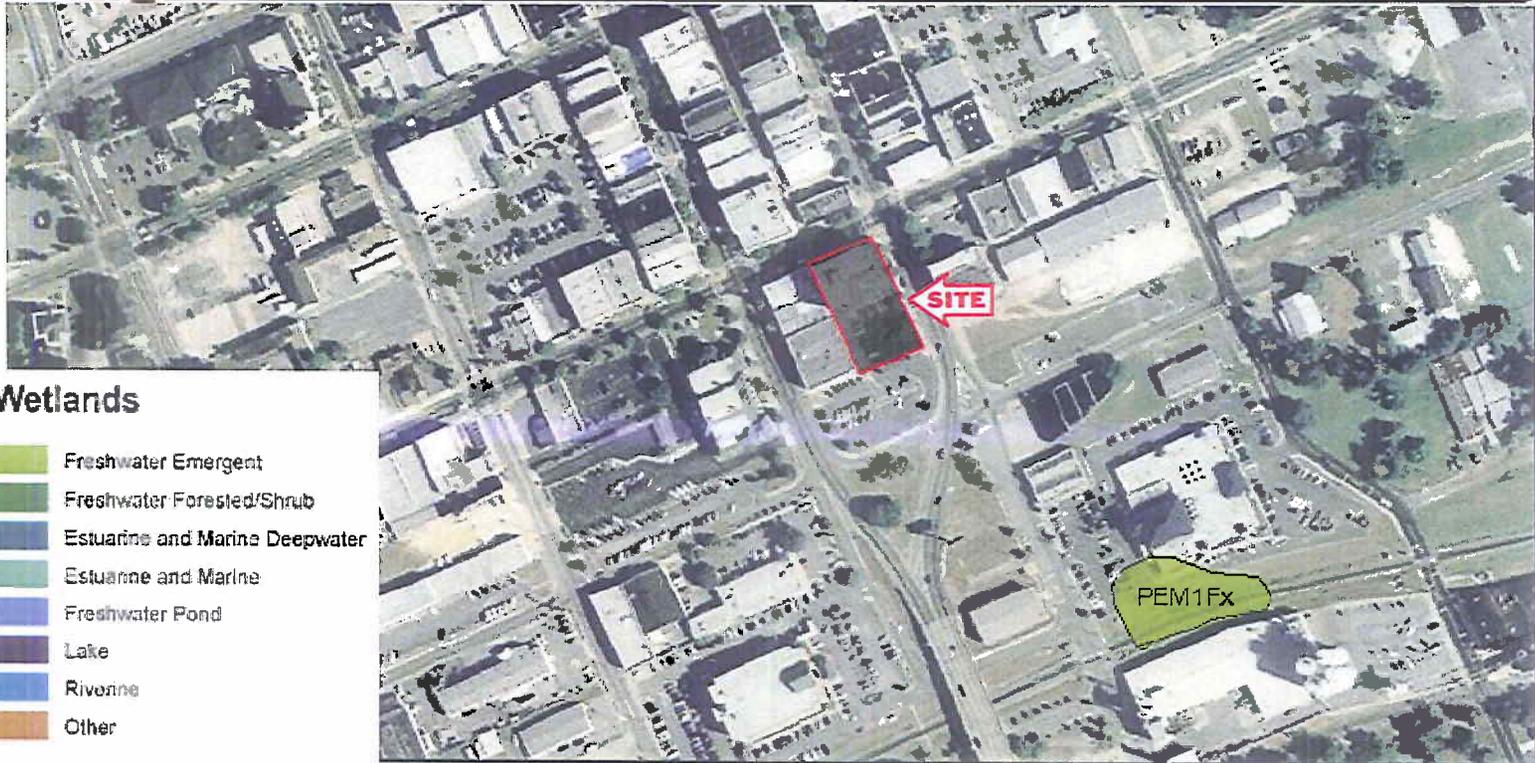
GEC reviewed the U.S. Department of the Interior Fish and Wildlife Division National Wetlands Inventory (NWI) Map. The National Wetlands Inventory (NWI) map is a tool used to investigate if wetlands are on a specific property. Wetlands on these maps are usually indicated from the review of aerial photographs, U.S.G.S. Topographic maps, and soils maps. Wetlands are not necessarily field delineated for inclusion on the NWI Map. According to the map, no wetland areas were identified on the subject property. A copy of the NWI Map is presented as Figure 2, Appendix A.

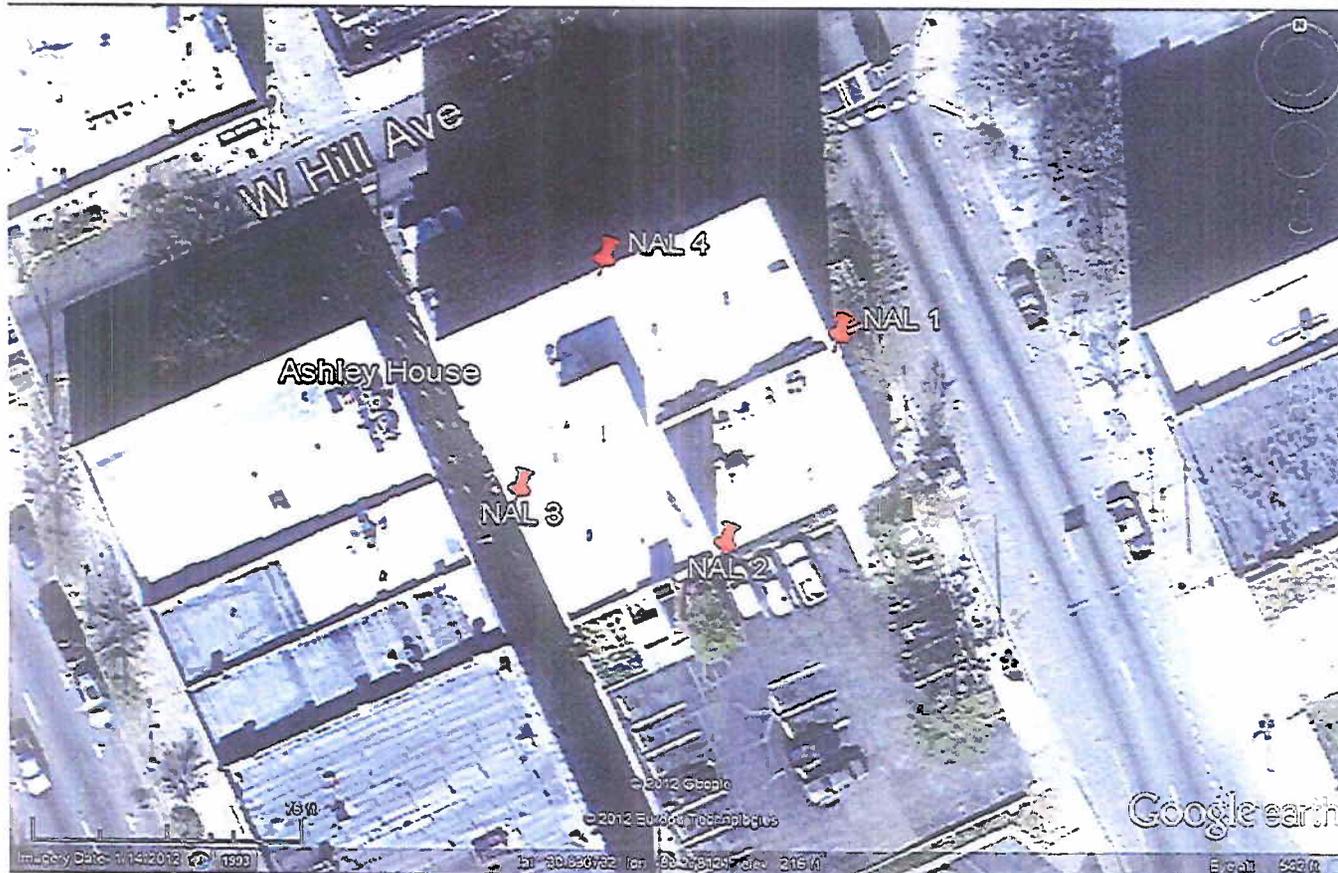
Noise Assessment Locations (NALs)

St. Patterson St. 2010 AADT 8920 (TC 003);
 Per GDOT Website Trucks 11%: Cars 89%, Med Tks 5.5%, Lrg Tks 5.5%
 2022 AADT at 3%/yr 12718; Cars 11320; Medium Trucks 699; Large Trucks 699

The development includes a seven-story apartment building, with adjacent parking, as depicted in Figure 1 (attached), copied from the GEC NAG study. The GEC NAG study predicted noise levels at four noise assessment locations (NALs). All resident-occupied site locations are above 70 DNL and one location, NAL 1, as shown in Figure 1 is above 75 DNL. Figure 1 shows the location of the NALs and their calculated DNLs and the combined DNLs. Figures 2, 3 & 4 (attached), also copied from the GEC NAG study, pinpoint the locations of the potential noise sources relative to the subject site. Ashley Street is situated east of and adjacent to the subject site. Hill Avenue is situated north of and adjacent to the site. Patterson Street is located approximately 150 feet west of the subject site. Savannah Street is situated approximately 240 feet south of the site. A CSX Transportation railway is located approximately 715 feet south of the subject site. A Norfolk Southern railway is located approximately 1,005 feet south of the subject site. Valdosta Regional airport is located approximately 2.8 miles north of the subject site. Moody Air Force Base air field is located approximately 9.8 miles northeast of the subject site. Completion of the Noise Assessment Guidelines (NAG) worksheets, using the Site DNL Calculator available on the HUD Website for roadway and railway calculations, indicates an Unacceptable (per the NAG) exterior day night level (DNL) greater than 75dB as a result of these potential noise sources, except as noted above.

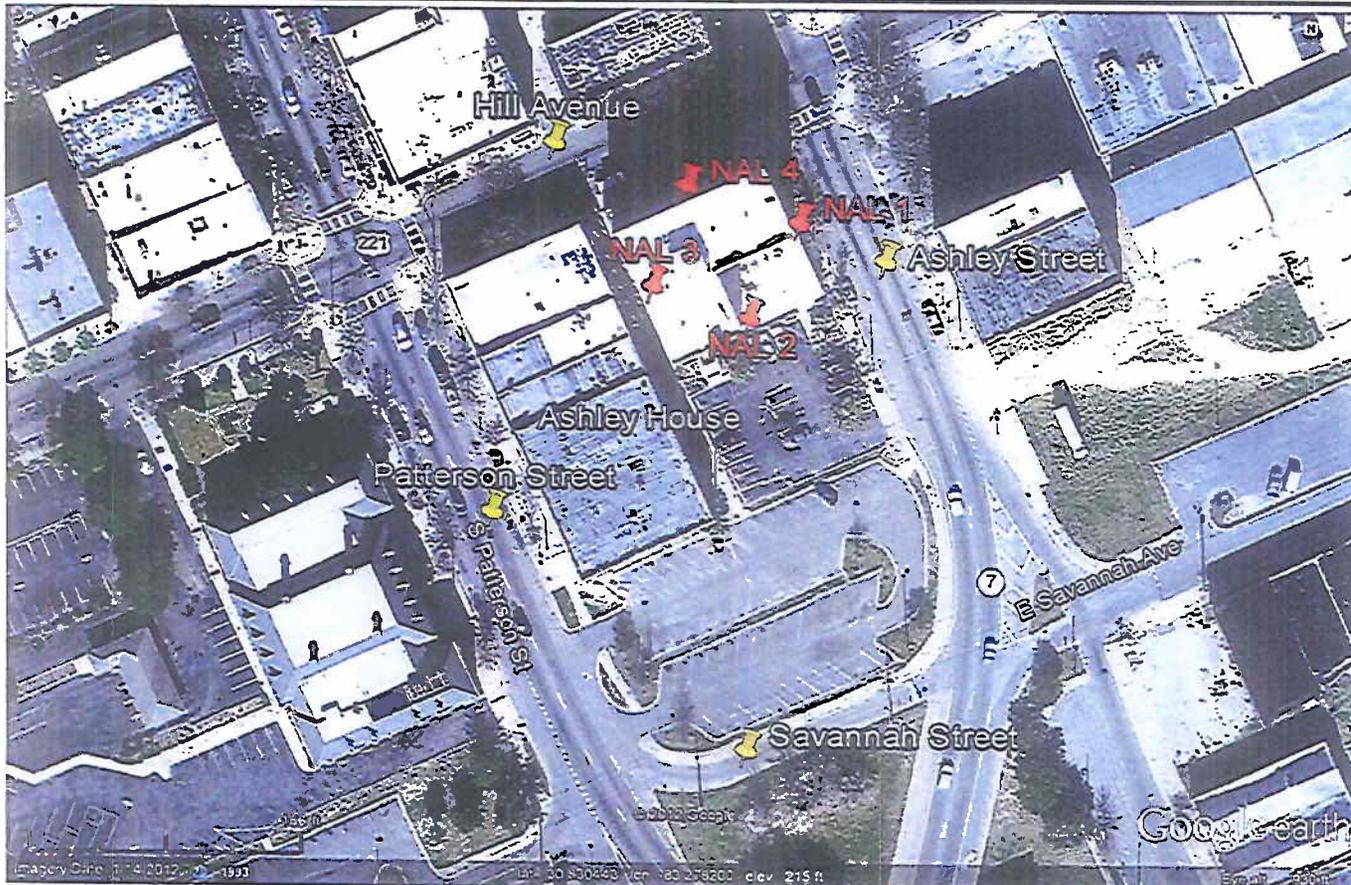
Noise Assessment Locations (NALs)

Figure 2 Ashley House Apartments Mitigation Plan Ashley House Valdosta, Georgia GEC Project No. 120184.240	NAL	Total DNL (dB)	Ashley Street		Hill Avenue		Patterson St		Savannah Ave.	
			Distance (feet)	DNL (dB)	Distance (feet)	DNL (dB)	Distance (feet)	DNL (dB)	Distance (feet)	DNL (dB)
	1	75.7	40	74.4	85	67.9	250	62.5	285	60.3
	2	71.9	90	69.1	130	65.1	200	64.0	240	61.5
	3	71.9	140	66.2	85	67.9	150	65.9	280	60.5
	4	74.9	90	69.1	40	72.8	200	64.0	330	59.4
