Re: Pauldoe Redevelopment – Phase I, UC project 2011.2612.05

Phase I Environmental Assessment Pauldoe Redevelopment - Phase I Pauldoe Street, Pauldoe Court, And Hawthorne Avenue Athens-Clarke County Athens, Georgia

Project Number
2011.2612.05

Report Date:
May 29, 2012
Regulatory Review:
April 9, 2012
Site Visit:
April 16, 2012

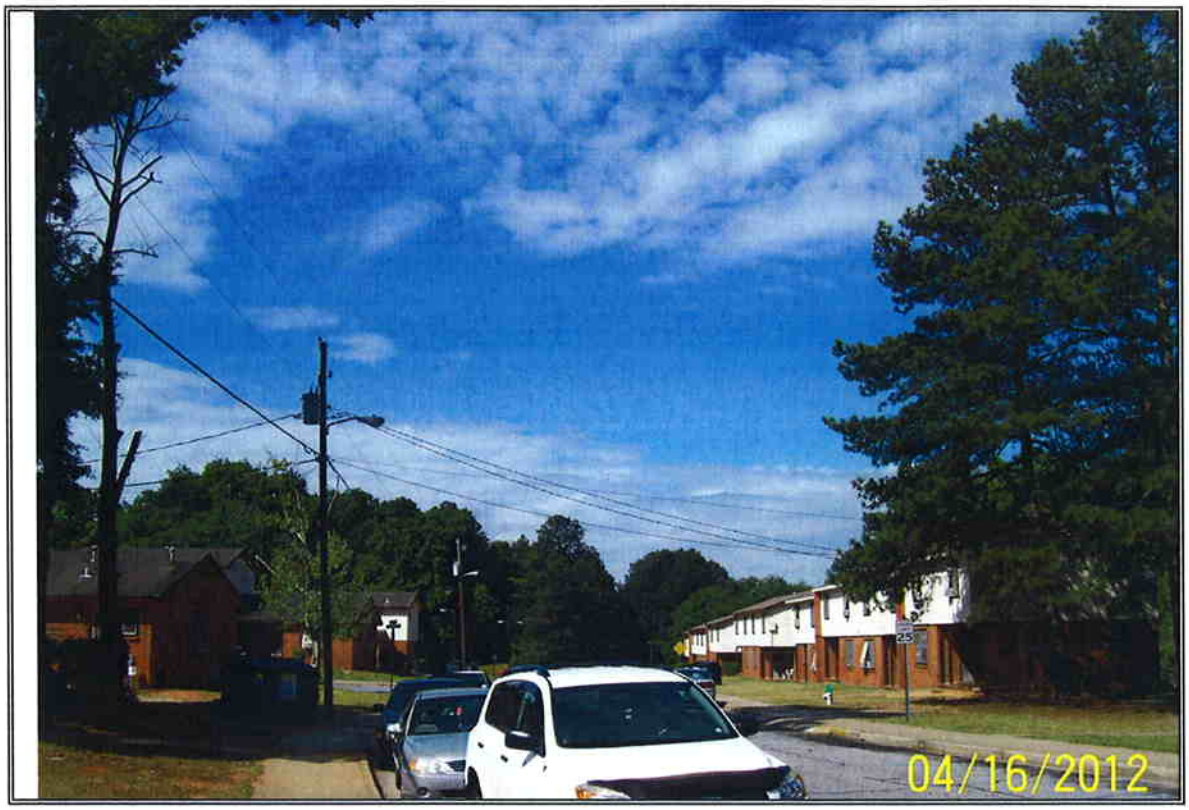
Photo # 2.: View looking northwest at Project Site structure located at 315 Hawthorne Avenue.
